PRODUCT NAME: StreamMaster™ II
AKRON PART NUMBERS: 3480 and 3482

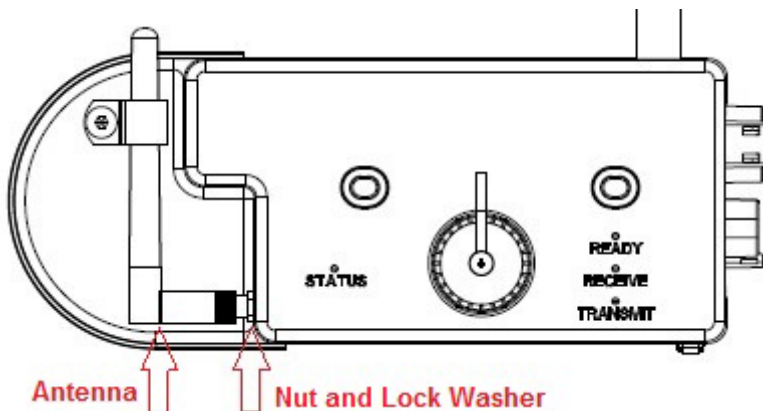
Some StreamMaster II monitors have experienced short range and/or intermittent movement when using wireless controls between the StreamMaster II, 3600 handheld controller and/or SIT module.

The antenna connector on the 6052 controller mounted on the monitor base may have a locking nut and washer on the threaded barrel that is preventing the antenna connector from fully engaging the feed line connector.

- 1 – Disconnect antenna.
- 2 – Remove Nut and Lock Washer.
- 3 – Discard Lock Washer.
- 4 – Reinstall Nut.
- 5 – Reconnect antenna, and tighten.
- 6 – Check to make sure that there is a gap between the antenna connector and the nut.
- 7 – If the antenna connector touches the nut, it will be necessary to remove and discard the nut also.
