## **PRODUCT NAME: SG Gearbox**

## 2<sup>ND</sup> COOLING TUBE IDENTICATION & PARTS

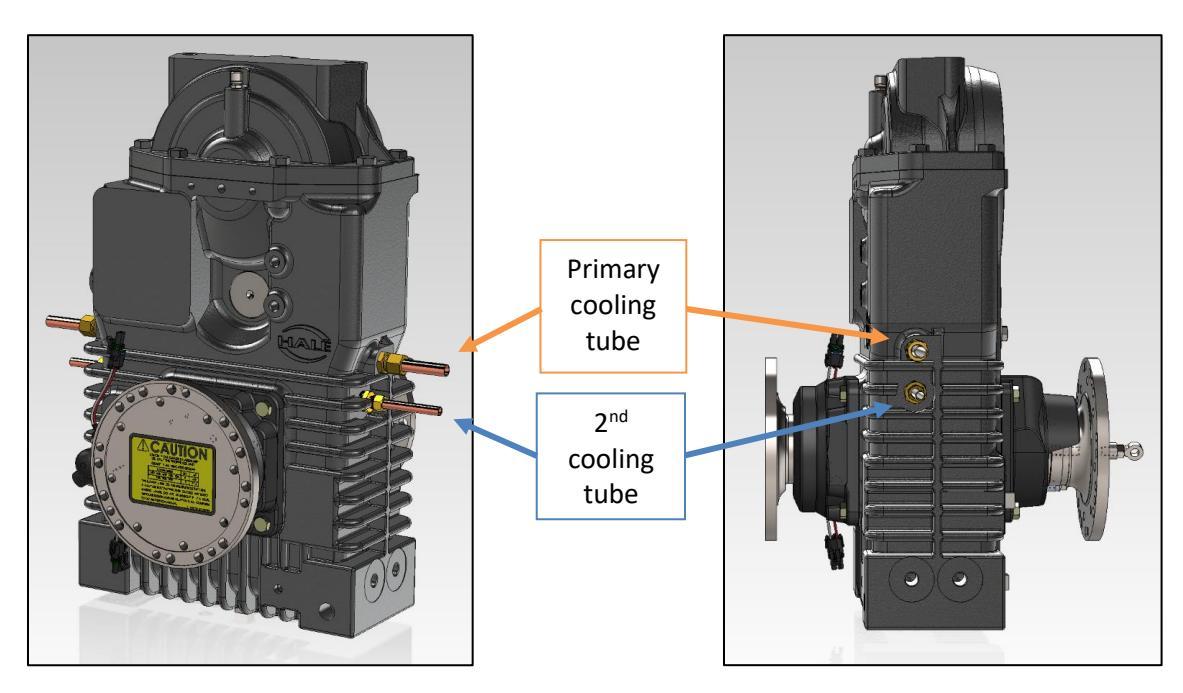
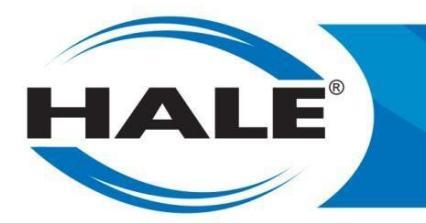
- The Primary cooling tube is the standard copper, straight 1/2" OD tube (shown in Hale PL914).
- The 2<sup>nd</sup> cooling tube is the additional copper, curved 3/8" OD tube. The 2<sup>nd</sup> cooling tube is located 1.75" below the primary cooling tube.
  - Tube part number: 007-00167-000
  - Fitting part number: 082-0422-03-0 (1/2" MNPT x 3/8" Compression, Straight)

Visual inspection of your gearbox will confirm the presence of the 2<sup>nd</sup> cooling tube. No immediate action is needed, but these tubes cannot be interchanged if disassembly of the gearbox is required.
